QUAD ESL-63 service data

description

The Quad ESL-63 is a full range electrostatic loudspeaker doublet. It consists of a very light electrically polarised diaphragm suspended between two sets of concentric annular electrodes. Signal is fed to the electrodes via sequential delay lines and the motion of the diaphragm produces a sound pressure pattern which is an exact replica of that from an ideal source placed some 30 cms behind the plane of the diaphragm.

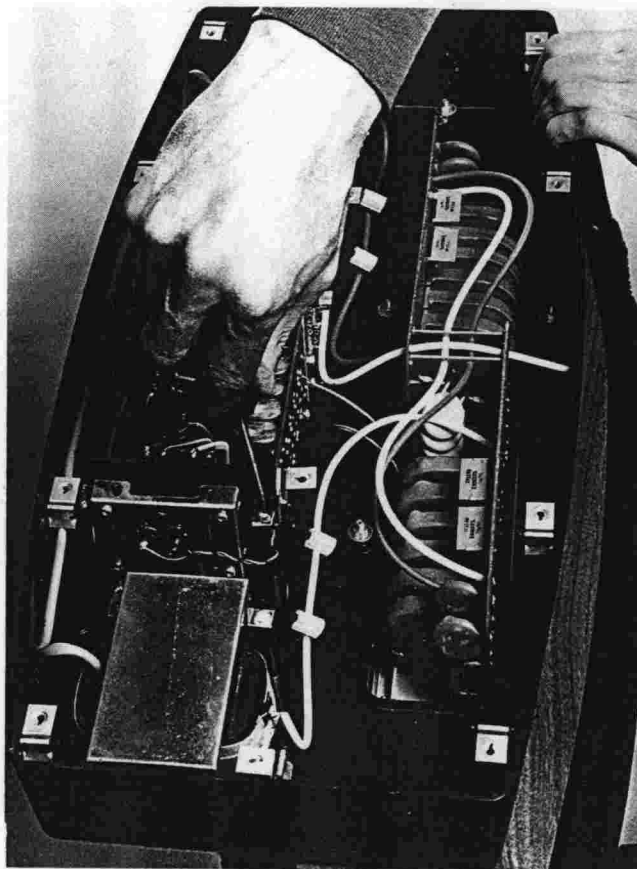
Fig. 7

- (b) The sub chassis holding the protection circuits, EHT power supply, input and AC connectors and fuse can be removed by undoing the four screws. Replacement of the protection circuit and EHT power supply is then quite straightforward.

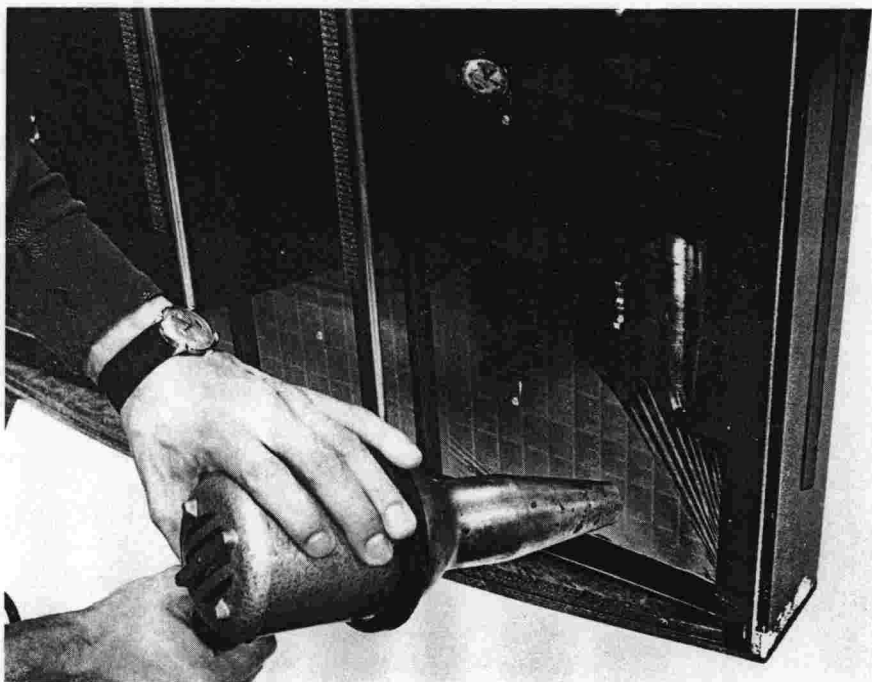
Fig. 12

- (e) With the faulty element replaced the loudspeaker can then be re-assembled in reverse order. Once the dust covers are in place they must be retensioned with a hot air blower to remove all wrinkles. A domestic hair dryer may not be hot enough but restricting the air flow by hand will raise the temperature sufficiently. The blower should be kept moving all the time in order to prevent burning a hole in the material.
